Manhole Inspection Summary

Manhole # S04AA2014MH

Insp Date: **9/29/06 9:39 AM**

Location Address: **6706 PARK HEIGHTS AVE**

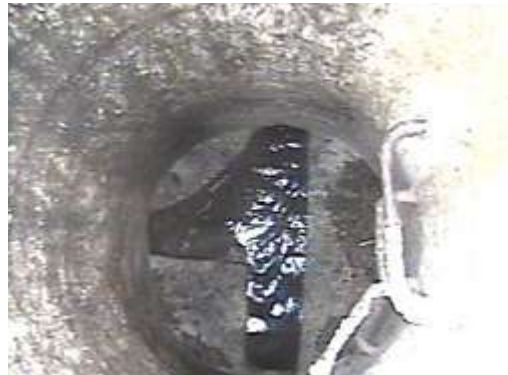
Top View

Corroded steps. Bench debris. Channel debris.

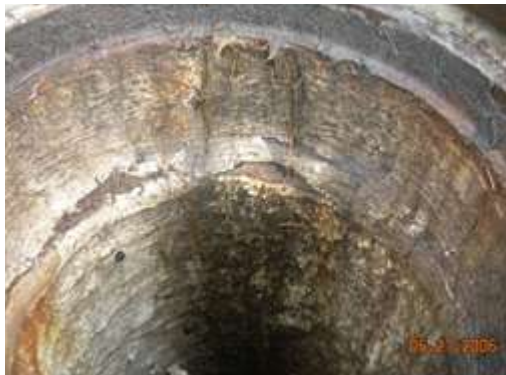
Defect

☒ **Leaks**

☒ **Root Intrusion**

☒ **Joint**

☒ **Roots**

☒ **Wall**

Frame leaks. Frame offset. Frame root intrusion. Adjustment root intrusion and infiltration.

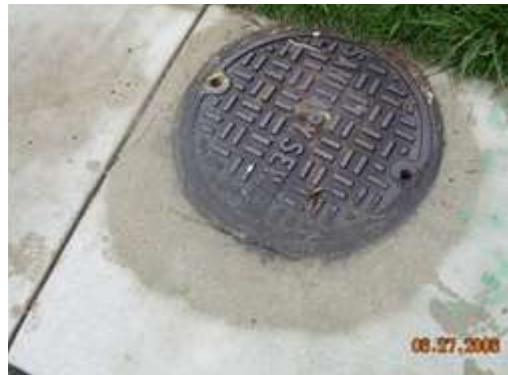
Defect

Subject To Ponding: **Ponding**

View of ponding.

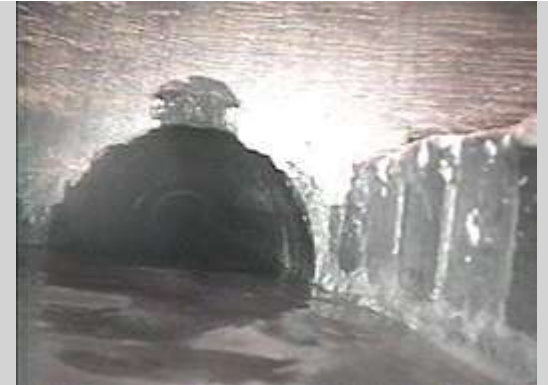
10 in. Circular Gravity Sewer Pipe Out @ 12 O'Clock

Deposits: ☐ None ☐ Mud ☐ Sludge ☒ **Debris** ☐ Grease

Silt Depth: **2** (in.) Deposits Extent: **Medium**

Infiltration: **Evidence** Pipe Seal Cond: **Unknown**

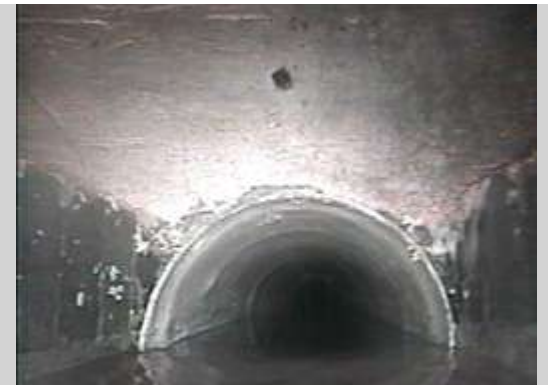
10 in. Circular Gravity Sewer Pipe In @ 6 O'Clock

Deposits: ☐ None ☐ Mud ☐ Sludge ☒ **Debris** ☐ Grease

Silt Depth: **2** (in.) Deposits Extent: **Medium**

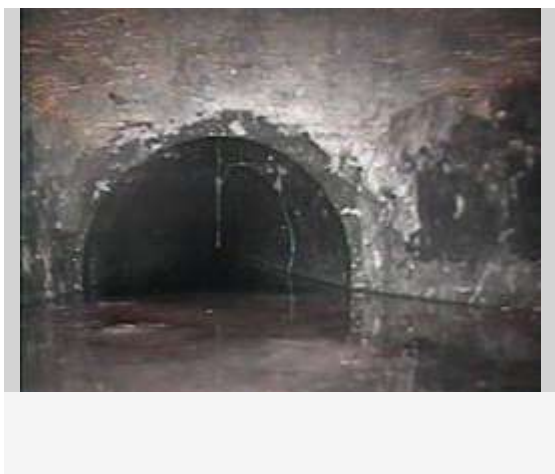
6 in. Circular Gravity Sewer
Pipe In @ 9 O'Clock

Deposits: ☐ None ☐ Mud ☐ Sludge ☒ **Debris** ☐ Grease

Silt Depth: **0.5** (in.) Deposits Extent: **Light**

Infiltration: **None** Pipe Seal Cond: **Roots**
